## Tanzania Integrated Water, Sanitation and Hygiene (iWASH) Program

### MINDU DAM BATHYMETRIC SURVEY REPORT

BATHYMETRY SURVEY CARRIED OUT MAY 2014  
REPORT FINALIZED JANUARY 2016

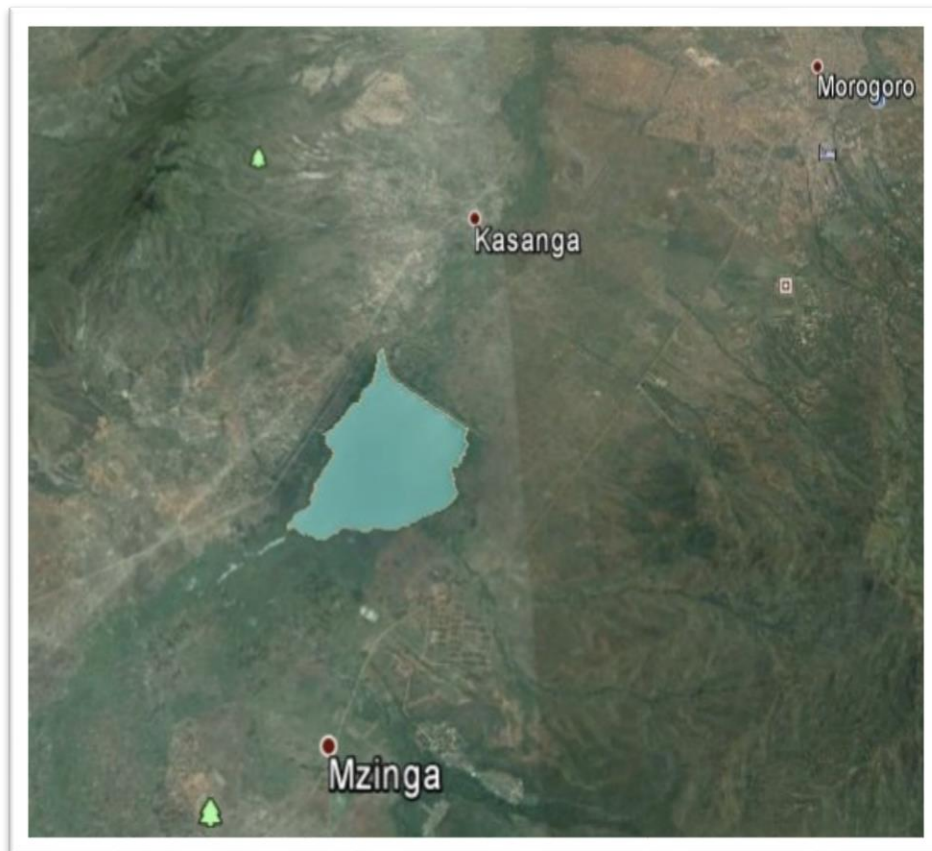
The first step was to roughly obtain dimensions of Dam that could assist with planning of the fieldwork. Mindu Dam shape was established from Google Earth imagery, which gave the shape of a rough pentagon lake wider on the Dam wall side and the thinner end representing one of the Rivers that fills the Dam.

Figure 2: Mindu Dam from Google Earth
