HYDROLOGICAL BULLETIN - FEBRUARY, 2020

WAMI/RUVU BASIN WATER BOARD

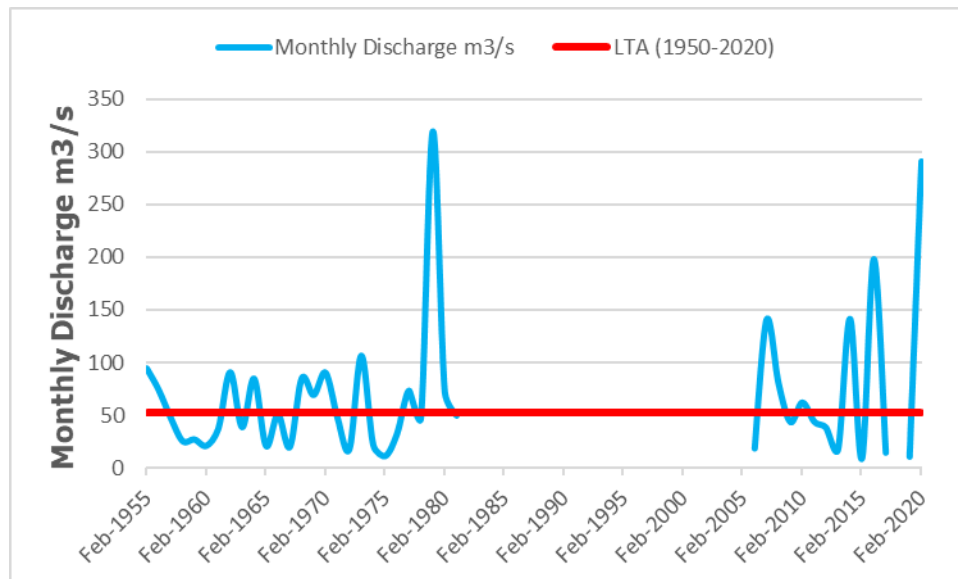
The average flow for Feb, 2020 was above compared to the long-term average values. Whereby the average flow value recorded was **291.31m³/s**. The maximum flow value observed was **556.330m³/s** on 05th of Feb, 2020 and Minimum flow value was **116.19m³/s** on 27th of Feb, 2020.

FIG. 3.2: FLOW VARIATIONS RECORDED AT 1G2 LAST STATION IN LOW REACH WITHIN WAMI CATCHMENT.

Wami river at Mander (1G2) station represent the Wami Catchment (Fig. 3.1). The peak flow recorded in February, 2020 was closed to flow recorded in February, 1979 (Figure 3.2), this implies the flow return of 41 years.

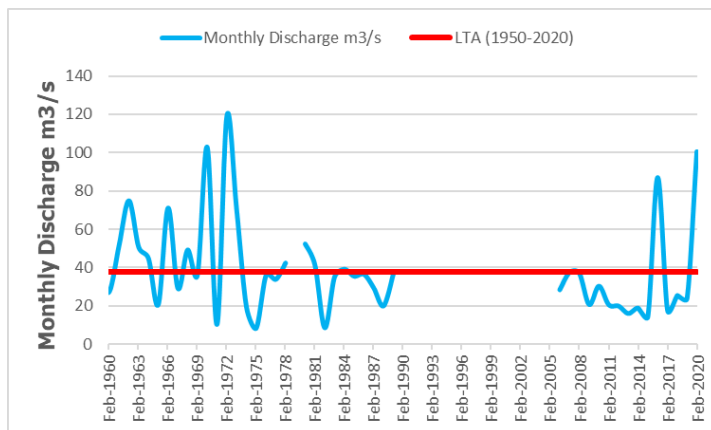
Fig 3.4; Monthly flow trend at 1H8A from Feb,1958 to Feb, 2020

Generally, the peak flow for February, 2020 was similar or closer to Feb, 1970 and 1972 (Fig 3.4) this implies the flow return of 50 years; the flow average for Feb, 2020 was above average compared to the long-term average values (1950-2010). The monthly mean flow which passes across the station was **100.6m³/s** which is much greater than the total abstraction upstream of the station as estimated from the water permits which is 13m³/s. The maximum flow observed was **150m³/s** on 01st of Feb, 2020 and the Minimum Value observed was **59m³/s** on 27th Feb 2020. This implies that there was no expected Water deficit for Environmental, Domestic and other users for this month.

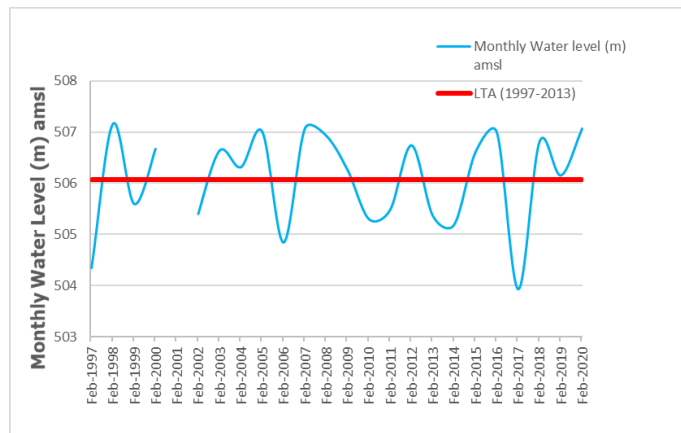
Figure 4.1; Water Level trend in Mindu dam from February 1997 to Feb, 2020

Always the month of February was the critical month in Morogoro whereby there was a water supply rational due to decreases of water level (water storage) in the Mindu dam but the situation was quit difference for this year whereby water level for Feb, 2020 was approximately closed to the year of El-Niño 1997/1998; whereby in the El-Niño year the Monthly average water level for month of Feb was 507.166masl while in Feb, 2020 water level was 507.075masl (Fig 4.1).

The maximum water level recorded this month was **507.100masl** on the 01st of February, 2020 and the minimum level was **507.000masl** on the 29th of February, 2020 as well as monthly mean water level was **507.075masl** which corresponds to fully supply of reservoir which is 12 million cubic meter.

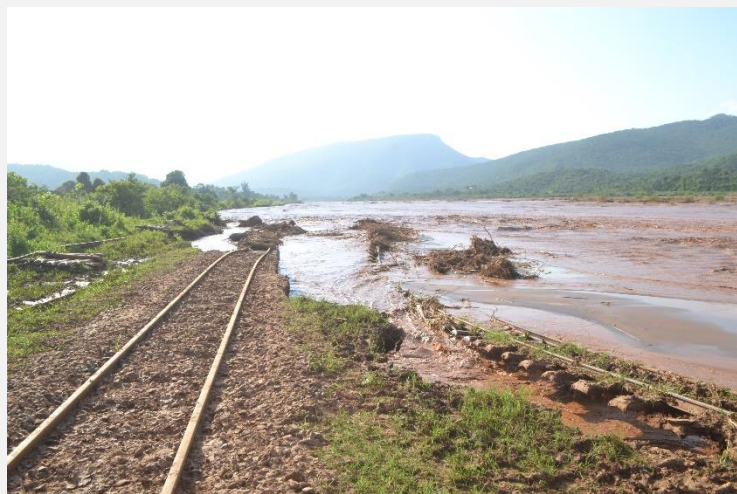
FIGURE 5-1: DAMAGE OF RAILWAY AT MUNISAGARA VILLAGE

- ✚ Collapse of river banks of Mkondoa River
- ✚ Damage of Railway about 300m between Munisagara, Mkadagi and Kilosa stations (Fig 5.1) and three houses were washed away.
- ✚ Various infrastructures were destroyed such as roads in Gulwe village.
- ✚ Gauging station of Mkondoa river at Kilosa (1GD2) was washed out.

As presented above, in Feb 2020 the basin received high rainfall especially in the north west part of the basin thus high levels in major rivers and streams. The flood events were observed in Kinyasungwe and Mkondoa rivers which caused damage of infrastructures like bridges, railways and roads.
